Project Name: Gold King Mine	Site Location: Silverton, San Juan County, Colorado	Project No. 0001/1408-01
--	---	------------------------------------

PHOTOGRAPH LOG

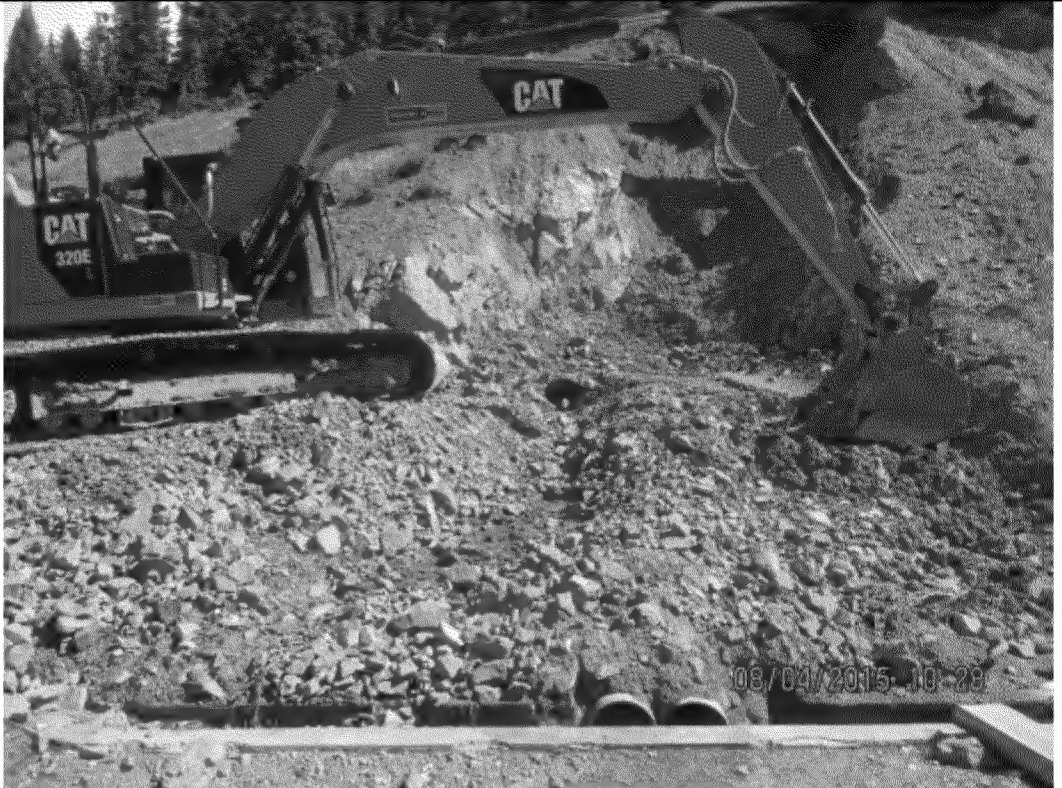
Photo No. 1	Date: 08/04/2015

Direction Photo Taken: North		
Description: Beginning investigation into collapsed adit.

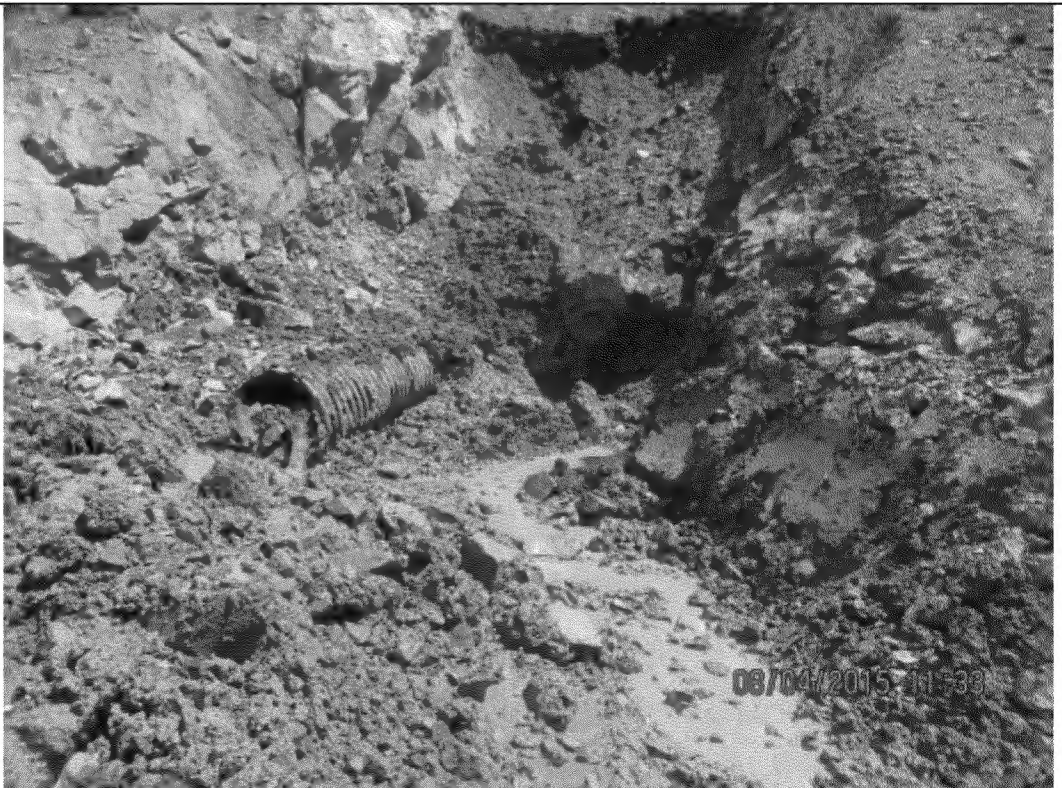
Photo No. 2	Date: 08/04/2015

Direction Photo Taken: North		
Description: Excavated next to DRMS-installed culvert, water muddy from soil disturbance.

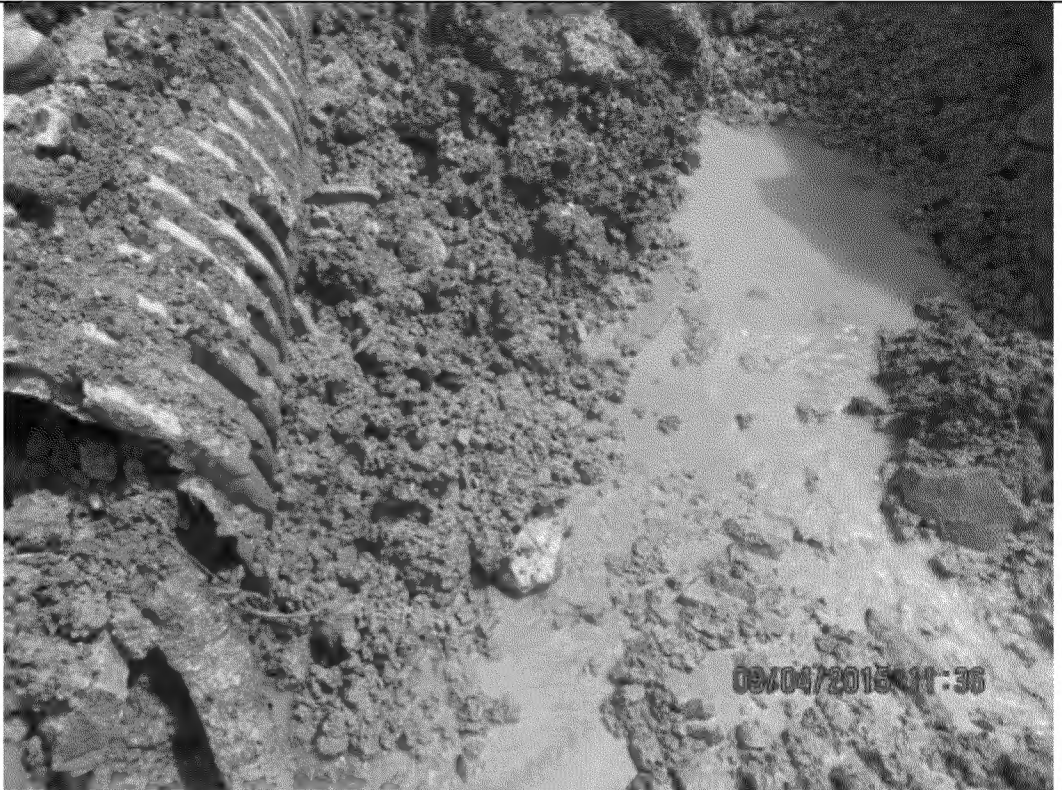
Photo No. 3	Date: 08/04/2015

Direction Photo Taken: Down		
Description: Seepage from soil next to piping.		
Photo No. 4	Date: 08/04/2015

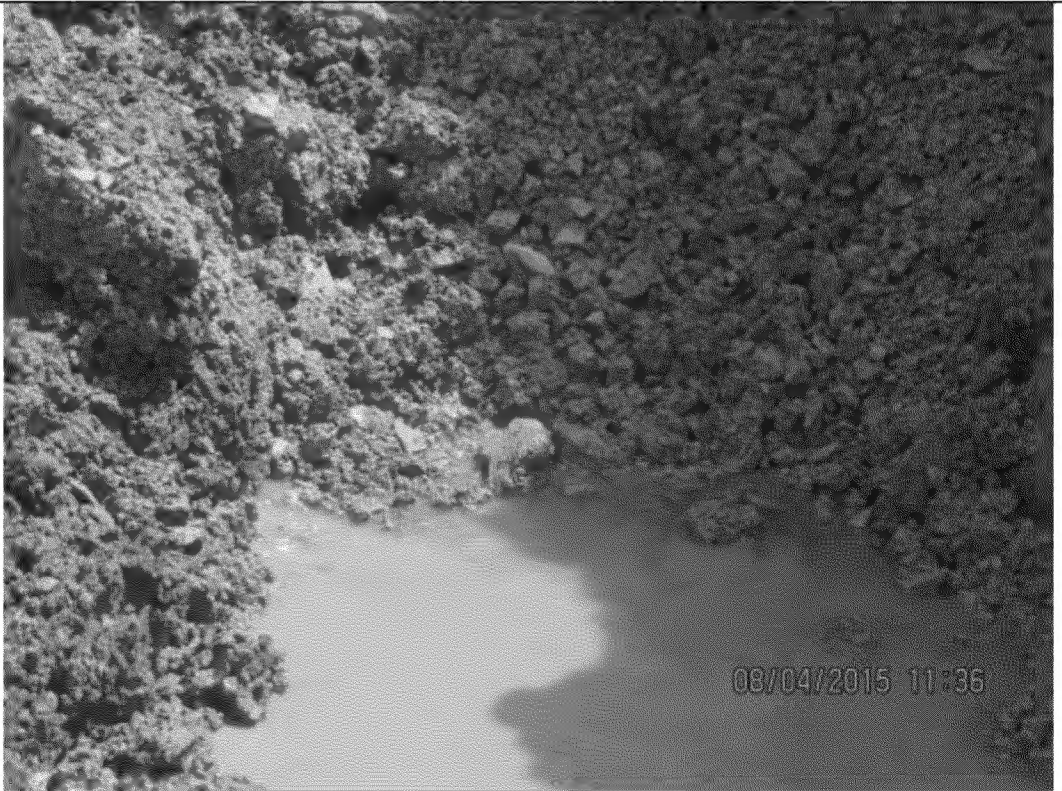
Direction Photo Taken: Down		
Description: Seepage next to the pipe is clear until entering disturbed soil.

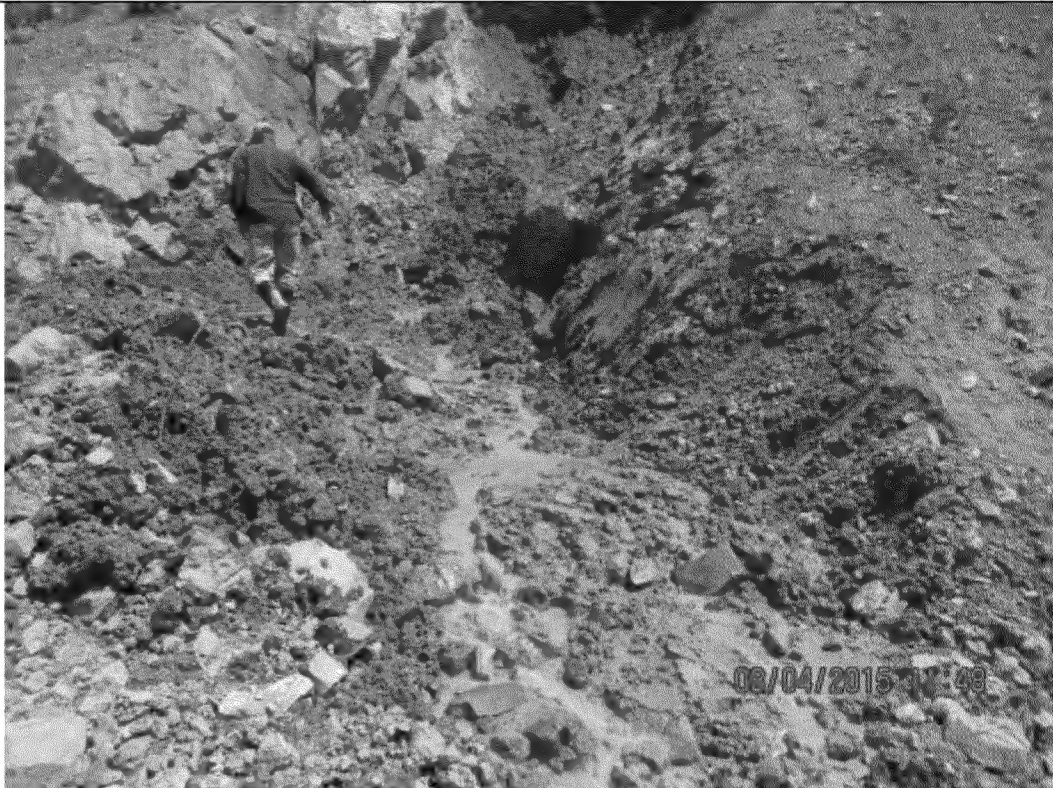
Photo No. 5	Date: 08/04/2015

Direction Photo Taken: North		
Description: DRMS looking at adit excavation progress.

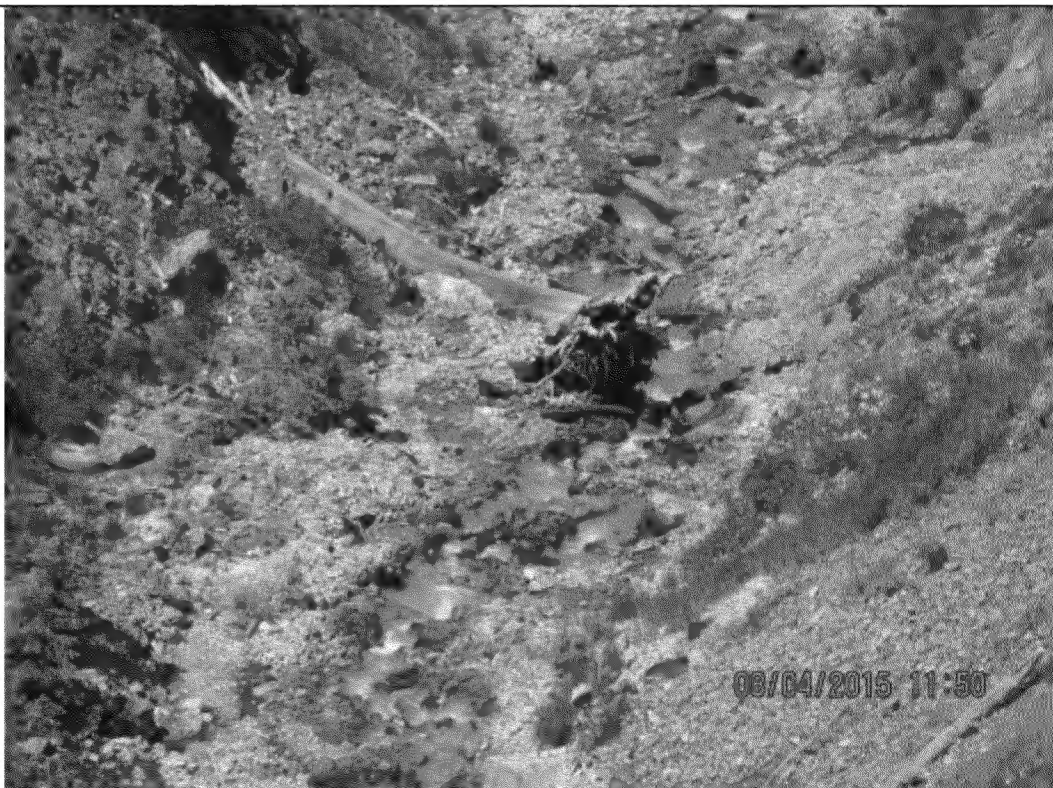
Photo No. 6	Date: 08/04/2015

Direction Photo Taken: West		
Description: Water minimally murky from disturbed soil and water entering the North Fork from site.

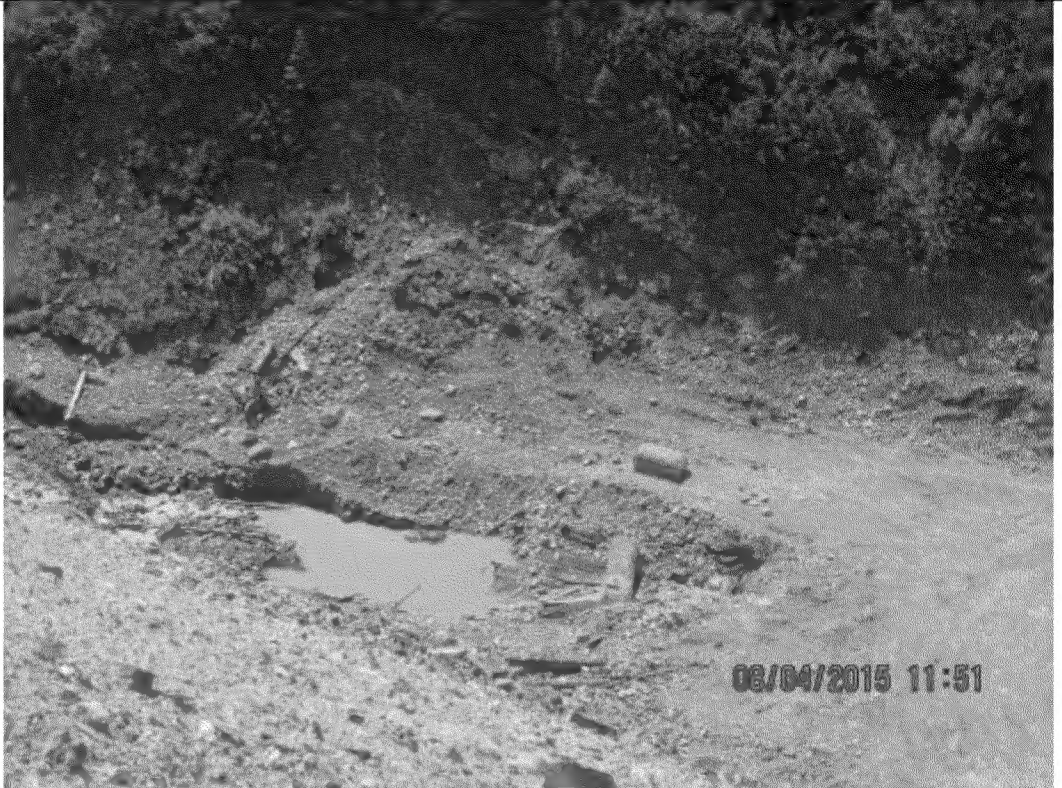
Photo No. 7	Date: 08/04/2015

Direction Photo Taken: South/Down		
Description: Hay bales installed as filter for sediment in North Fork.		
Photo No. 8	Date: 08/04/2015

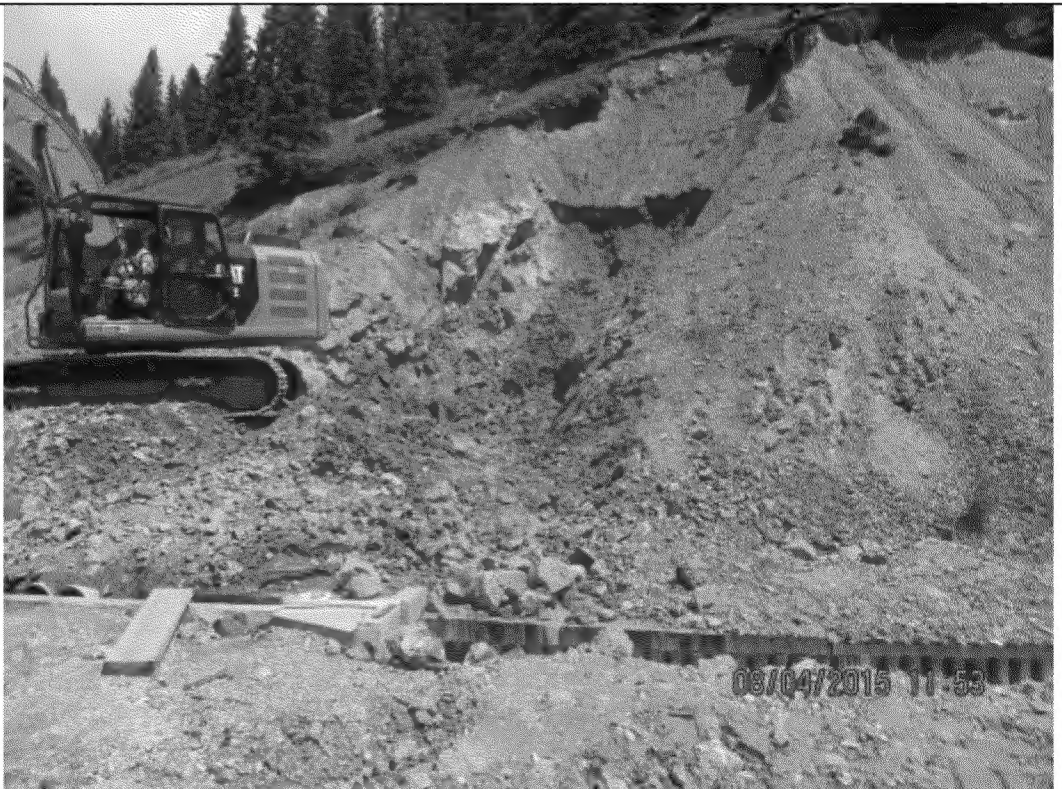
Direction Photo Taken: Northwest		
Description: Continuing excavation at the collapsed adit, no solid bedrock found for tunnel support.

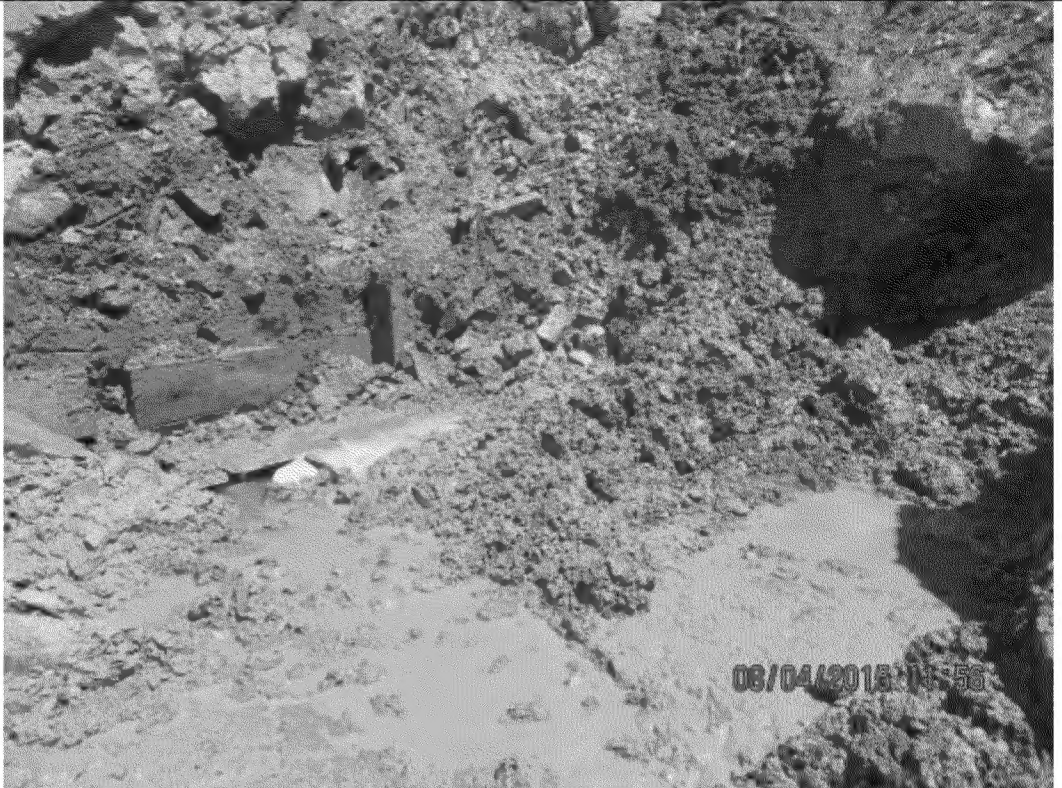
Photo No. 9	Date: 08/04/2015

Direction Photo Taken: Northeast		
Description: First signs of adit, support pillar with lagging.		
Photo No. 10	Date: 08/04/2015

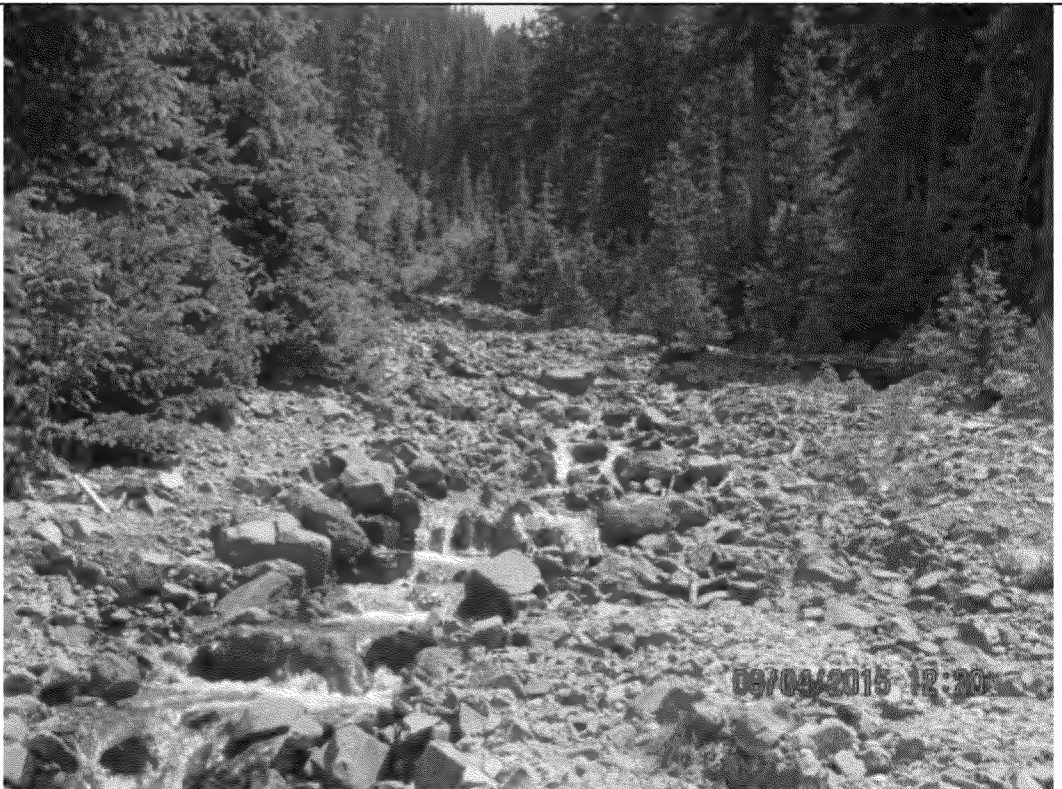
Direction Photo Taken: East		
Description: Water of the North Fork just upstream of Cement Creek.

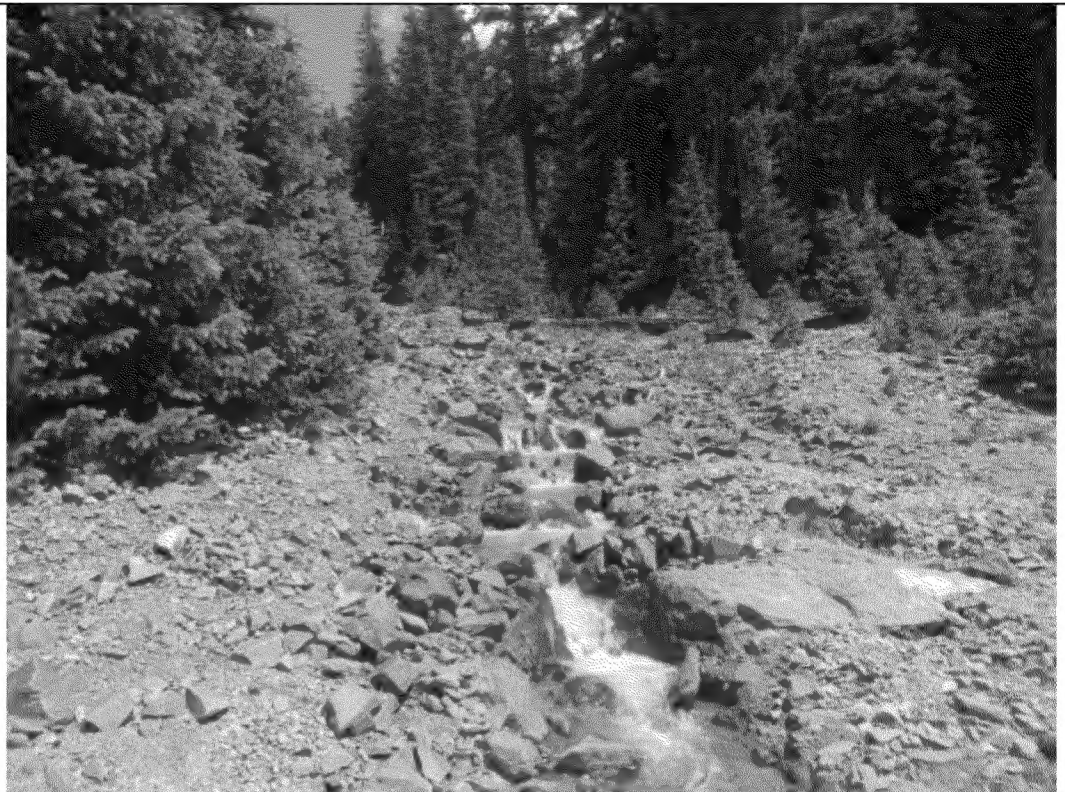
Photo No.
11

Water of the North Fork just upstream of Cement Creek.

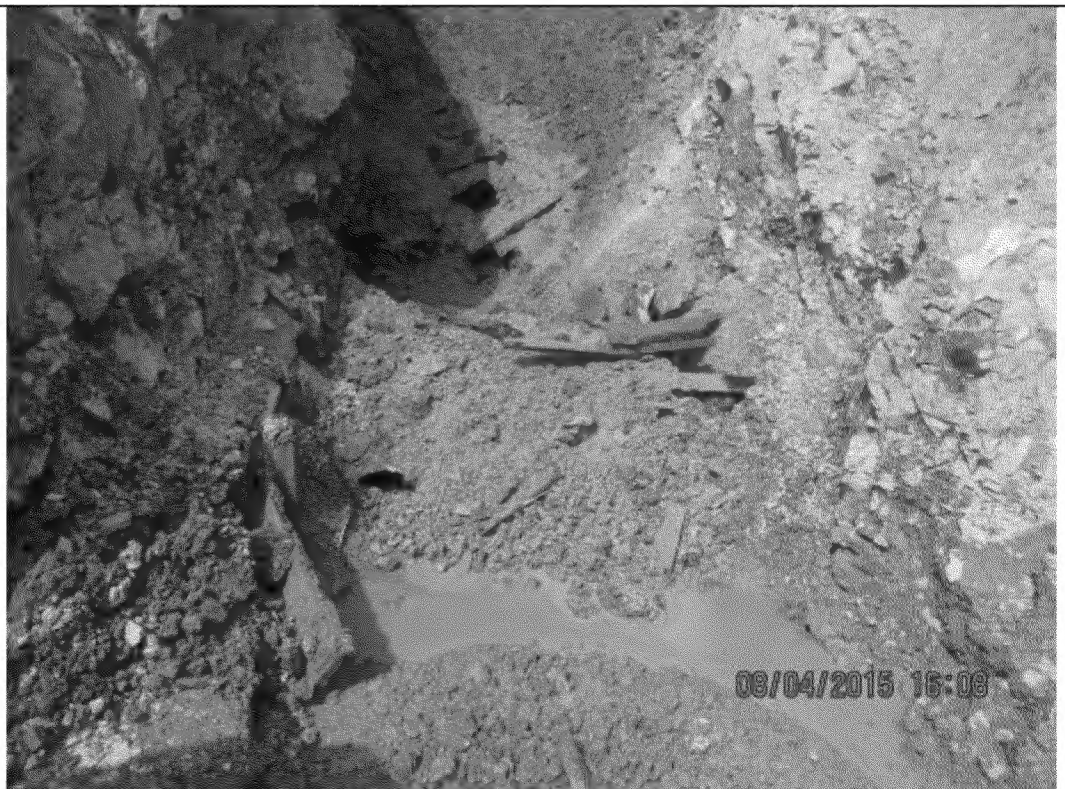
Photo No.
12

Collapsed supports uncovered above anticipated adit, no sign of bedrock above the adit area.

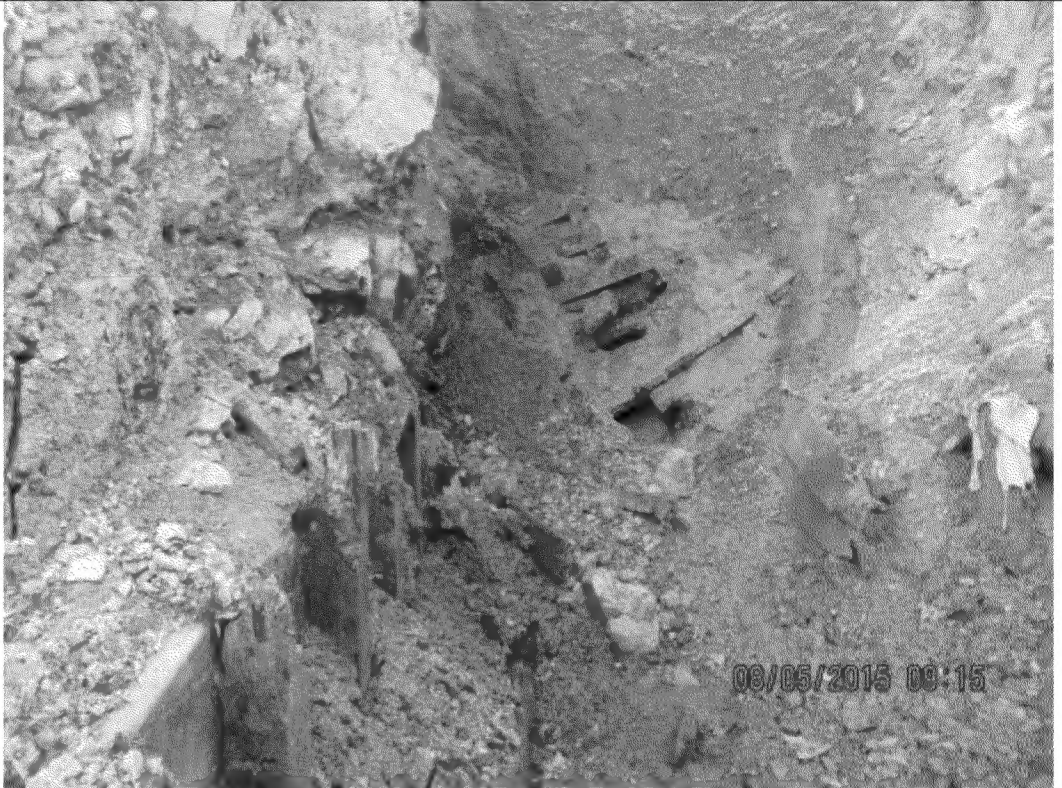
Photo No. 13	Date: 08/05/2015

Direction Photo Taken: North		
Description: Adit conditions the morning of 8/5.		
Photo No. 14	Date: 08/05/2015

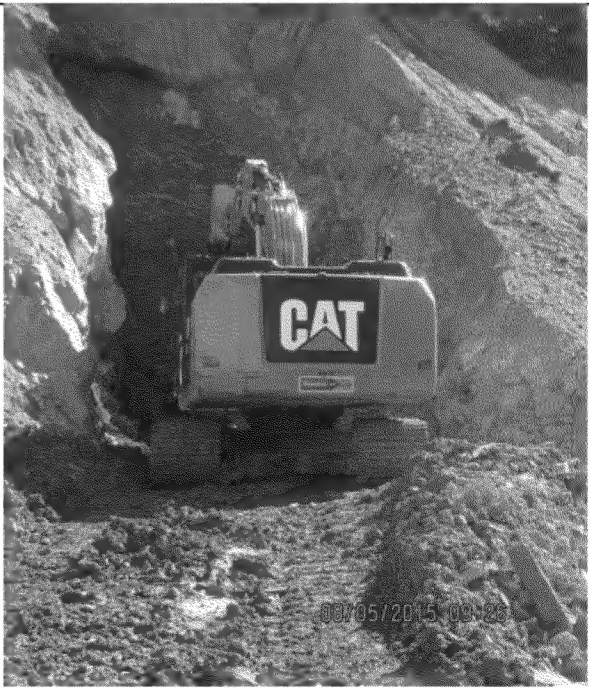
Direction Photo Taken: Northeast		
Description: Excavating material above the collapsed adit.

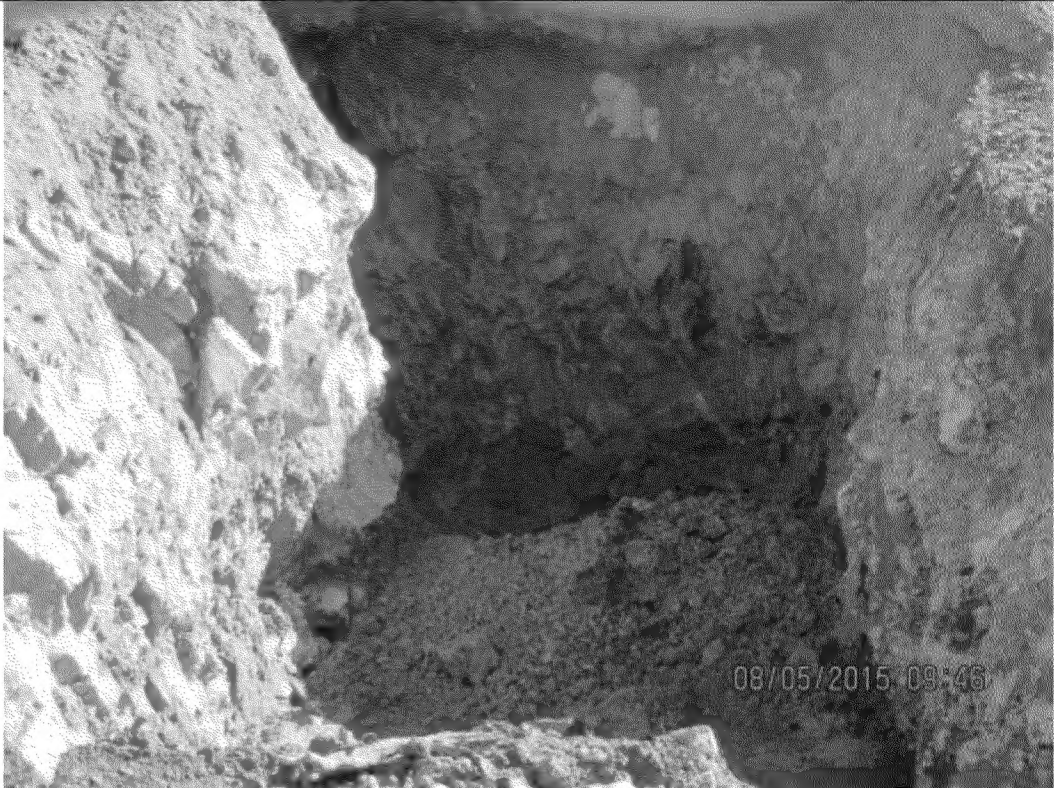
<p>Photo No. 15</p>	<p>Date: 08/05/2015</p>

<p>Direction Photo Taken:</p> <p>North</p>		
<p>Description: Bedrock found above the anticipated adit.</p>		
<p>Photo No. 16</p>	<p>Date: 08/05/2015</p>

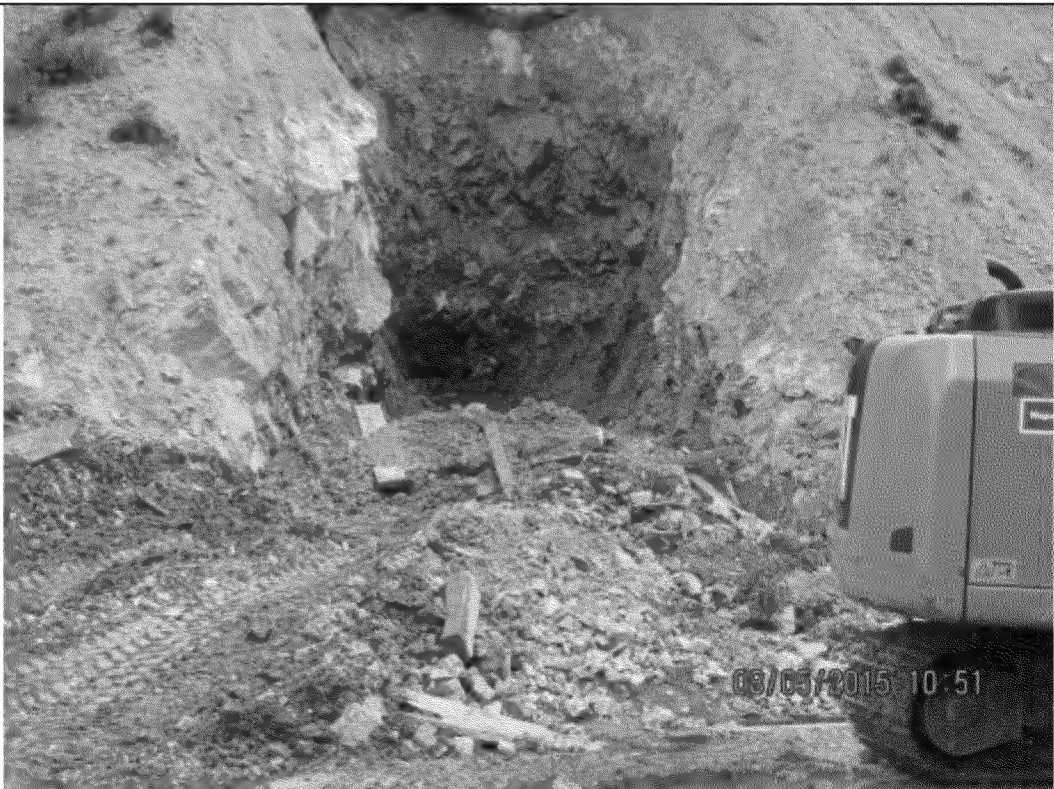
<p>Direction Photo Taken:</p> <p>North</p>		
<p>Description: Cleaning out excavated material, small leak.</p>

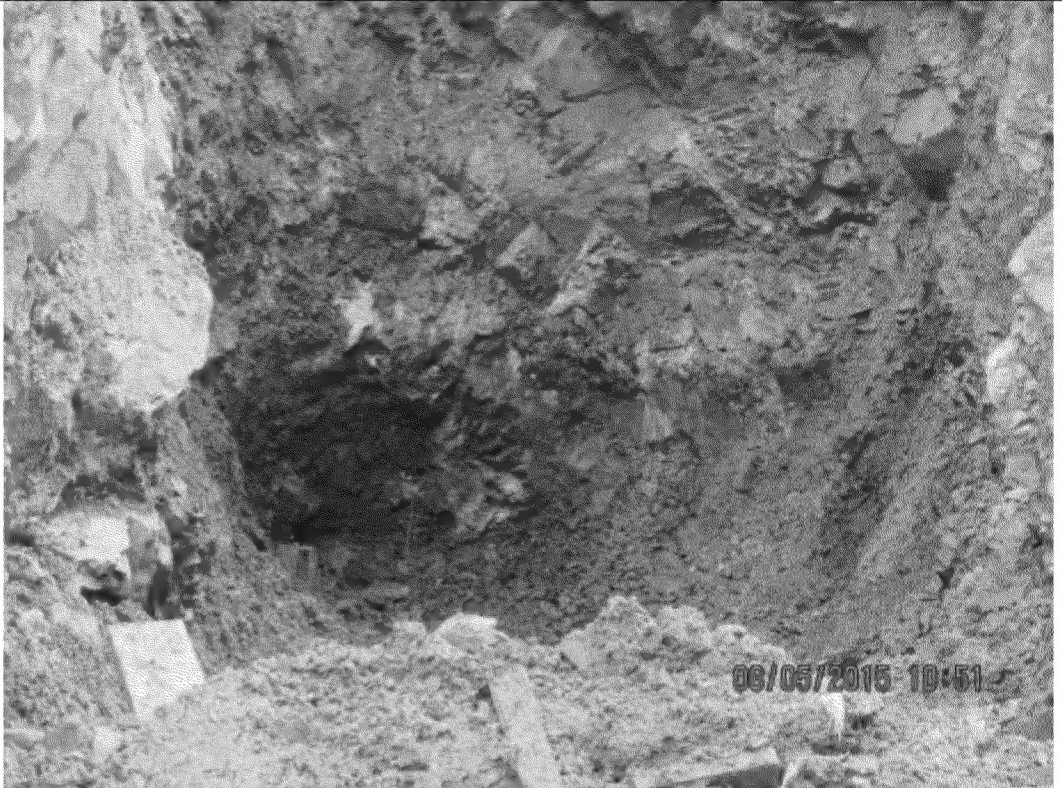
Photo No. 17	Date: 08/05/2015

Direction Photo Taken: North		
Description: Small leak close up.		
Photo No. 18	Date: 08/05/2015

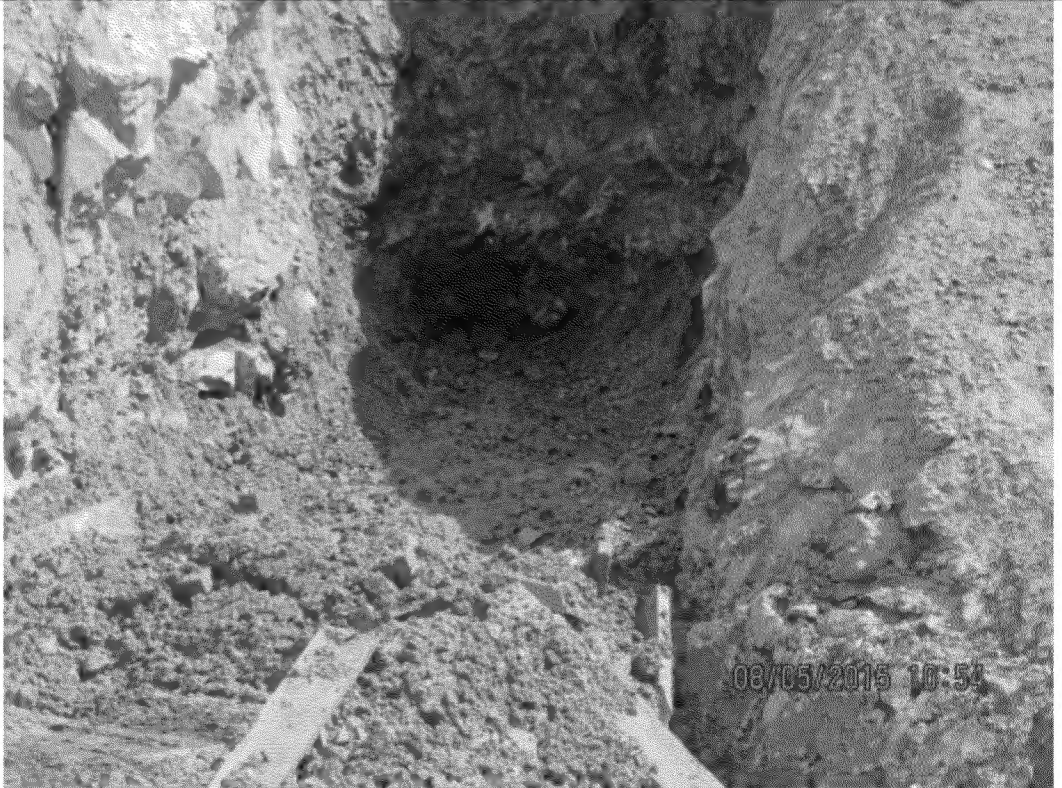
Direction Photo Taken: North		
Description: Hole starting to give way to flow.

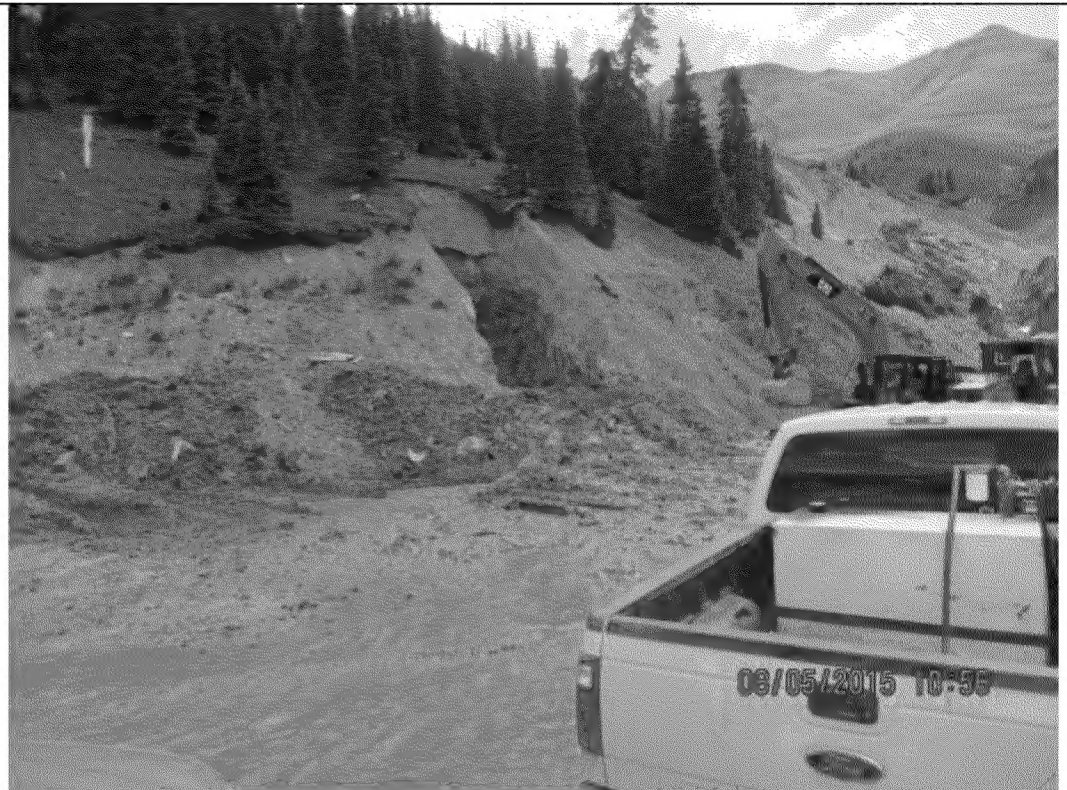
**Photo
No.
19**

Adit flow increasing.

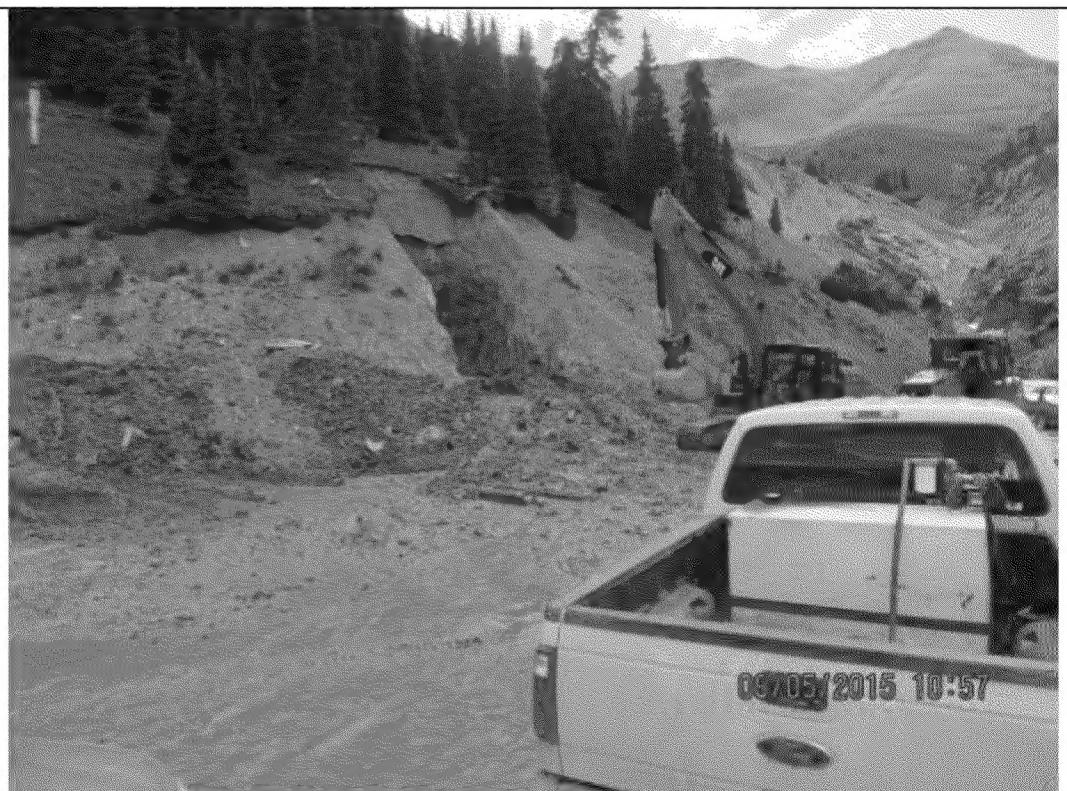
**Photo
No.
20**

Water flooding out at
increased rate.

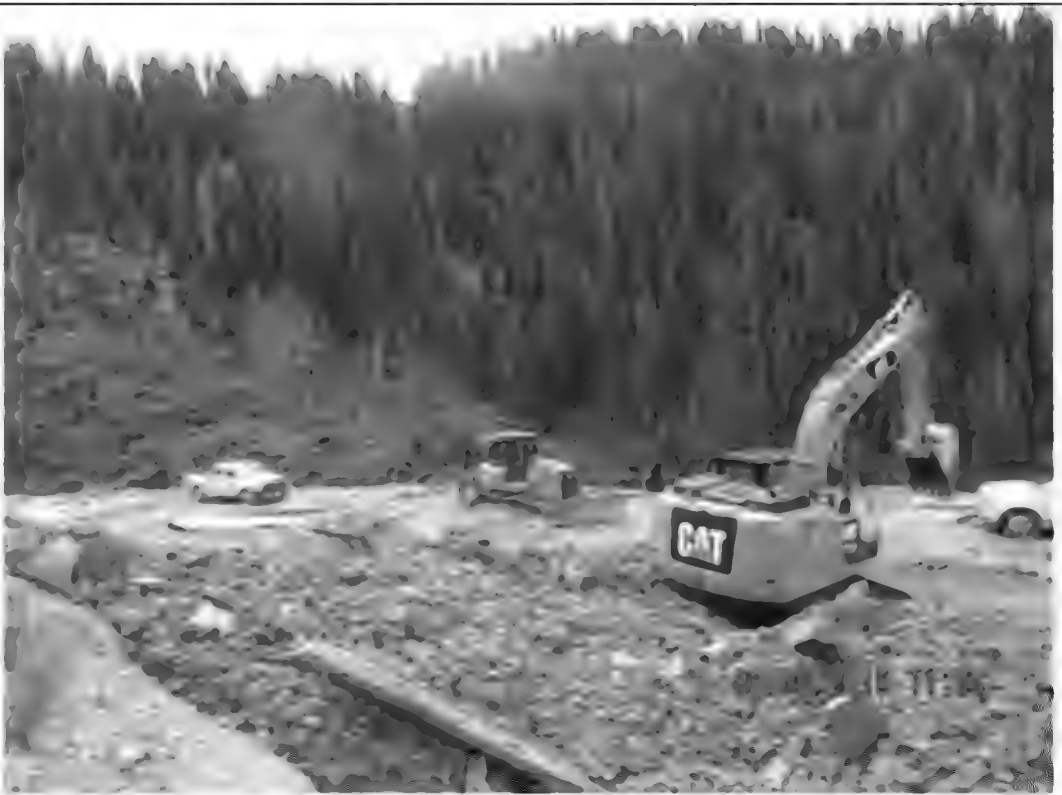
Direction Photo Taken: Southeast		
Description: Water flowing over the edge of the waste dump and collapsing the edge

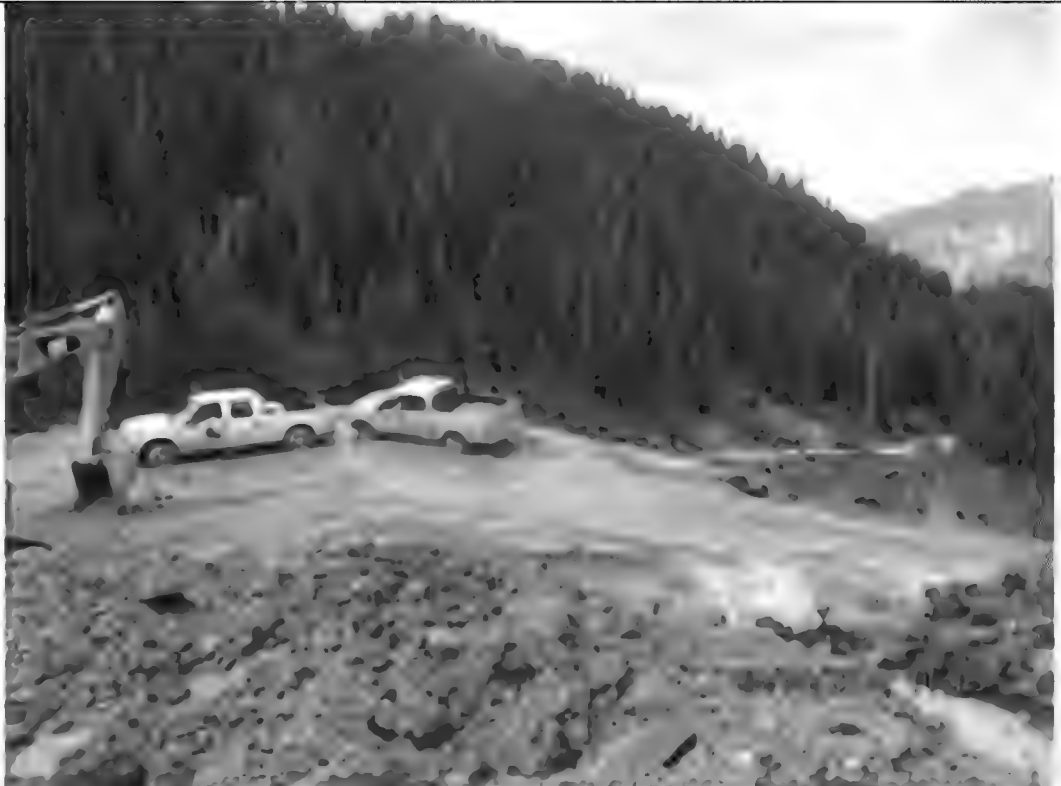
Photo No. 23	Date: 08/05/2015

Direction Photo Taken: Southwest		
Description: Exit route starting to collapse

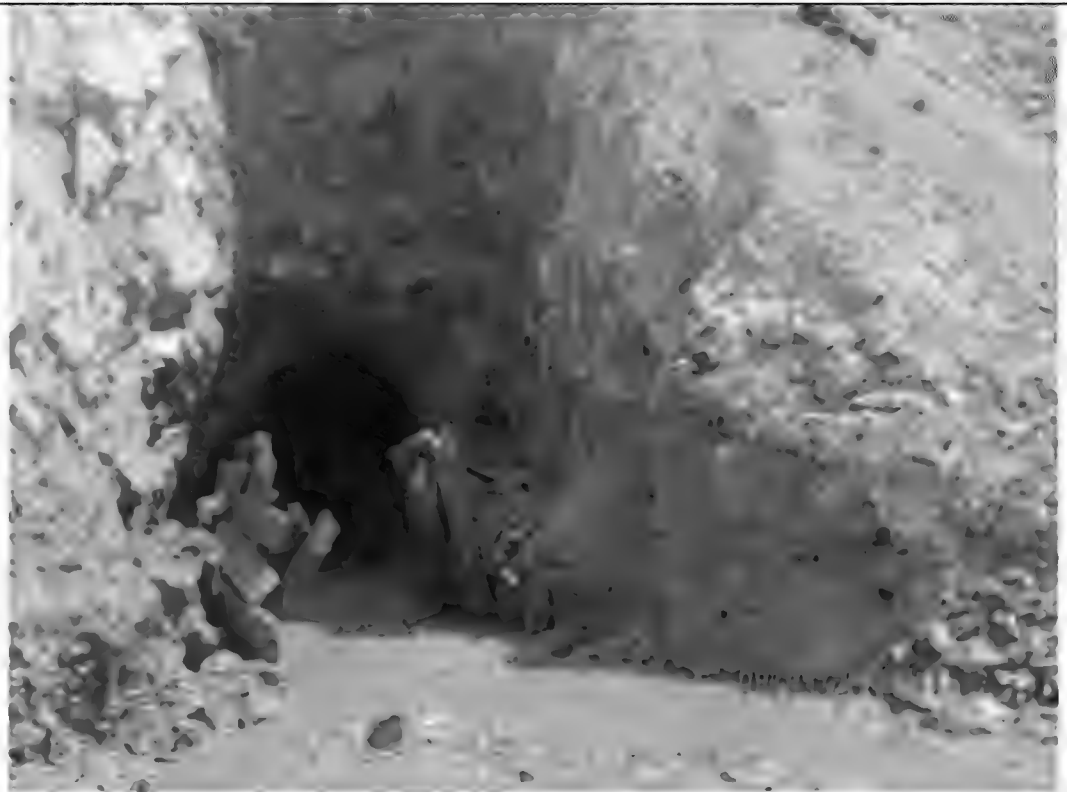
**Photo
No.
27**

Exposed adit, roughly
10 feet wide by 15 feet
high.

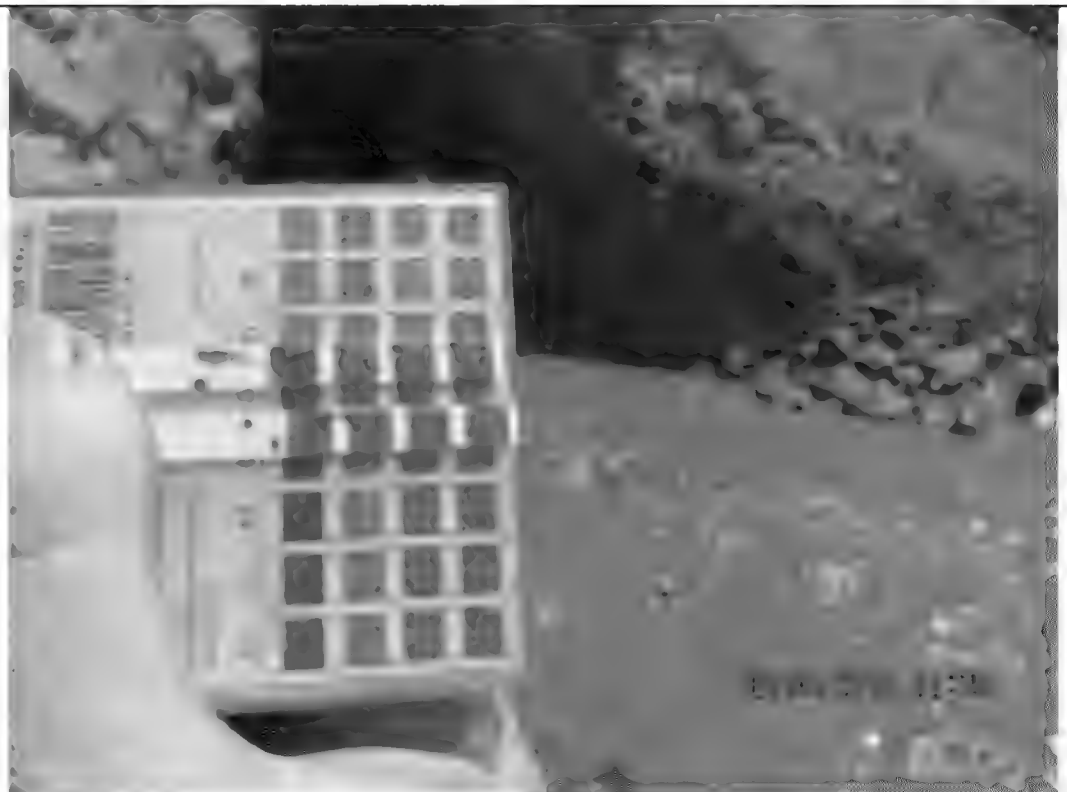
**Photo
No.
28**

pH of discharge water
is approximately 4 to
4.5.

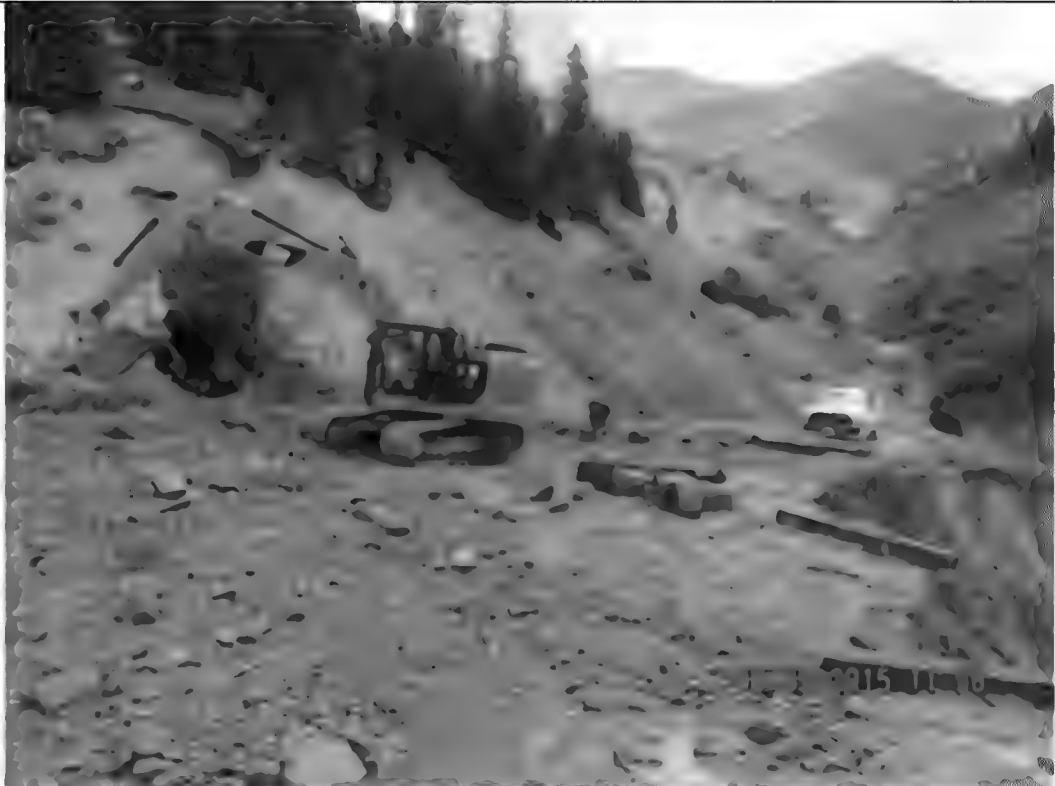
Photo No. 29	Date: 08/05/2015

Direction Photo Taken: Northeast		
Description: Excavator redirecting water into existing half-pipe channel

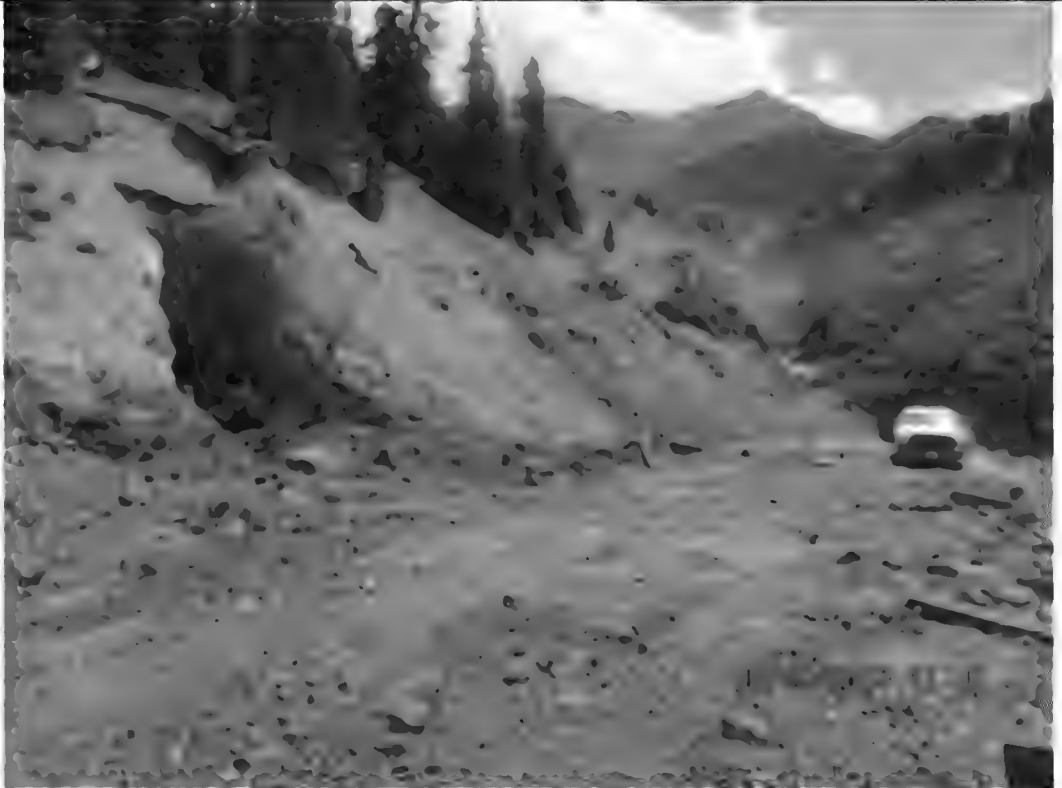
Photo No. 31	Date: 08/05/2015

Direction Photo Taken: Northeast		
Description: Adit area after regrading.		
Photo No. 32	Date: 08/05/2015

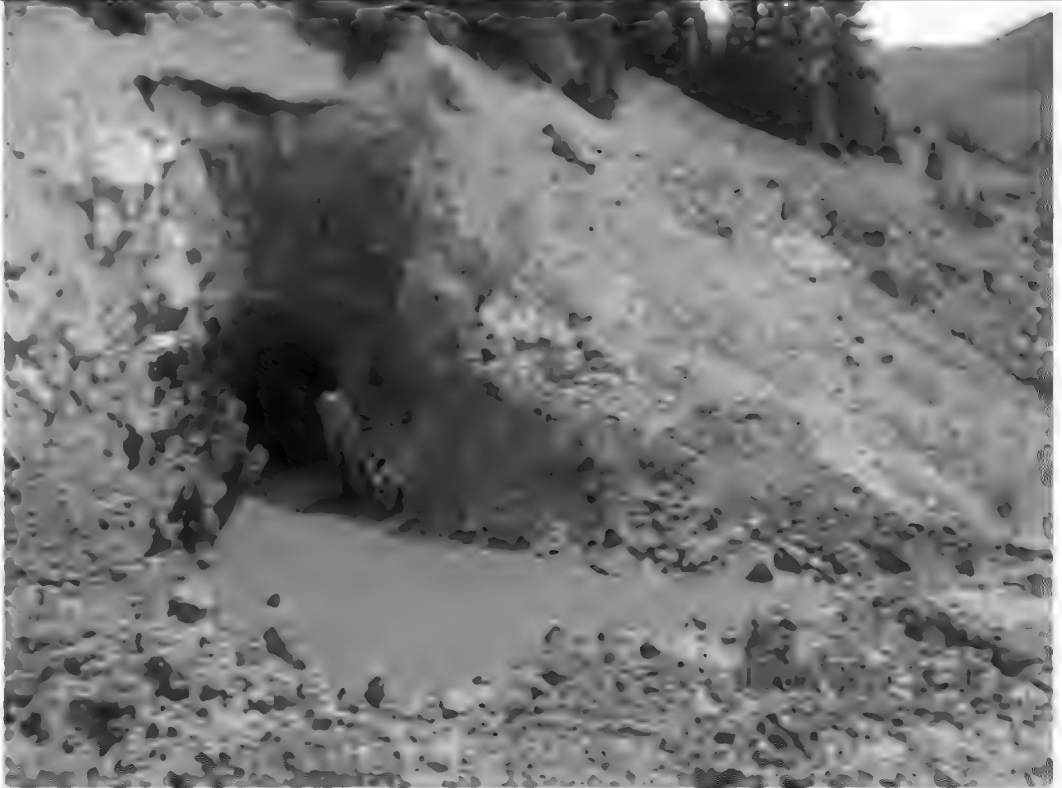
Direction Photo Taken: North		
Description: Exposed adit and redirected flow, flow is beginning to subside.
